Lifetime Critical Analysis of Alumina Calciner Refractories

B. H. Teider, B. Graham, M. A. L. Braulio, J. B. Gallo, V. C. Pandolfelli

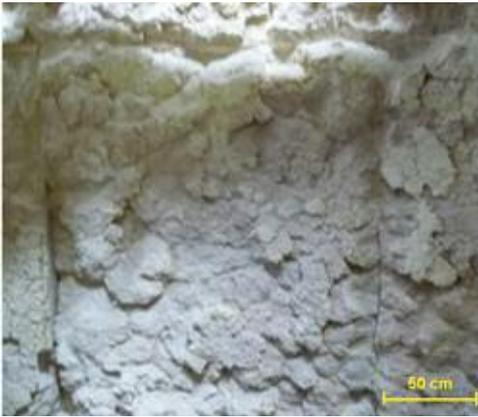
Fig. 1 Evidence of thermal degradation of the refractory lining panels

After a short time of operation, visual inspections in the calciner's combustion areas of the furnace and pre-heater vessels showed evidence that the refractory was not performing properly (Fig. 1) and resulted in an earlier and unexpected repair of the unit. Indications of refractory melting were detected during these inspections, most likely due to high operational temperatures.

Considering that using the same sort of refractory for repairing the damaged panels would result in a similar failure in the future, efforts were focused on understanding the conditions that the refractory was facing in

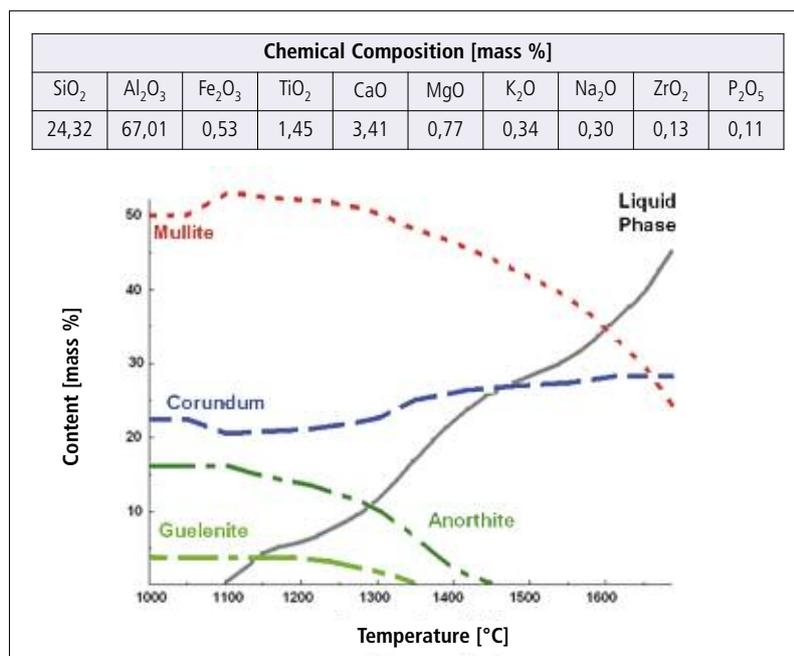
Fig. 2 Thermodynamic simulation of the mineralogical phases with temperatures for the pristine refractory chemical composition

In this study, the melting temperatures of calcium oxide containing phases were considered as fingerprints to identify at which temperatures the refractory was working within the vessels. The thermodynamic simulation (Fig. 2) showed the X-ray diffraction results, as well as a melting temperature of 1350 °C for gehlenite and 1450 °C for anorthite.

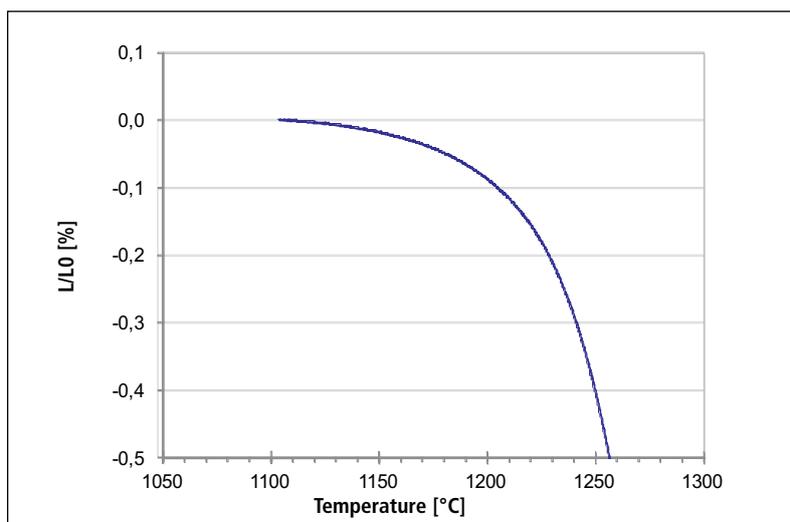
In addition to the X-ray results, which pointed out a mechanical strength loss potential at temperatures above 1350 °C, the refractoriness-under-load test indicated a maximum service temperature of 1255 °C, showing that even before the gehlenite's melting, the refractory's mechanical strength could already be spoiled. Considering the material's maximum service temperature and the working conditions, it can be stated that a critical operational situation for the refractory lining took place, which has ultimately reflected on its life time.

Fig. 3 Refractoriness-under-load test of the reference refractory

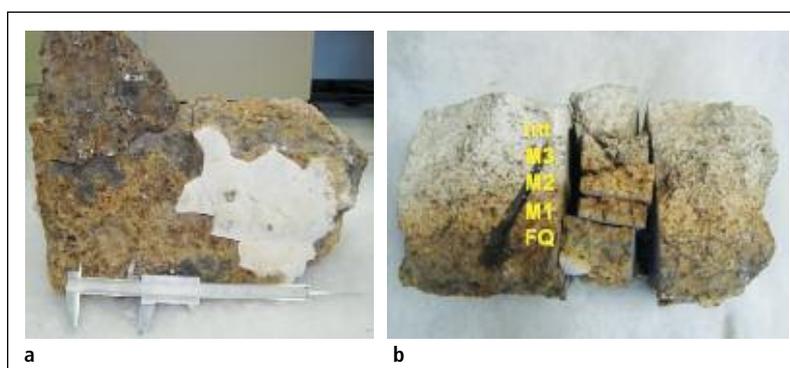
The first sample from the furnace vessel showed some visual aspect of degradation with an unusual surface porosity and alumina deposition in its hot face, as shown in Fig. 4.

Fig. 4 a–b Sample of the refractory material taken from the furnace vessel: (a) front view, and (b) top one

Despite the visual difference among the distinct regions of the selected sample (darker and more porous on the hot face and brighter at the back part of the sample), the phase analysis of all zones (Tab. 2), hot face (FQ), intermediate (M1, M2 and M3) and interface (Int), showed the presence of the same minerals in their composition, which firstly indicates that although it is known that temperatures may vary to some

extent due to the lining's thickness, in this case all dense lining layer faced fairly similar temperatures. Secondly, the gehlenite's absence points out that the refractory operated above its maximum service temperature.

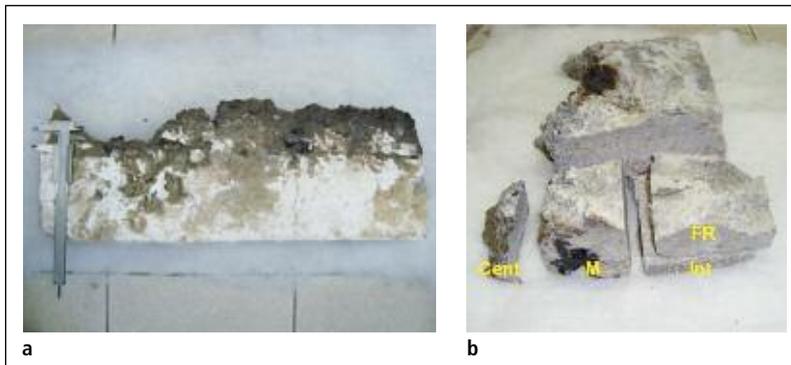
Fig. 5 Sample of the refractory material taken from the pre-heater vessel: (a) top view, and (b) cross sectional one

the service temperatures attained at least 1350 °C, but less than 1450 °C. The second sample, collected in the pre-heater vessel, was withdrawn from an almost fully molten panel that presented only a small remained piece of material and showed a severe degradation pattern with dark areas due to the partially burned fuel, alumina deposition in its surface and signs of vitreous phases, as shown in Fig. 5.

This refractory sample was divided into four specimens and the constituent phases were identified. Unlike the furnace's sample, the X-ray analysis (Tab. 3) showed that they did not present the same mineralogy, indicating that different service temperatures most likely took place. The sample located at the most central area of the refractory panel (Fig. 5, Cent) showed a clearer vitreous phase than the others us-

ing quantitative X-ray analysis, which agrees with the fact that it may have faced the highest temperatures, as this region of the panel melted. However, the presence of anorthite in this sample shows that the temperature at the specimen's inner part could not have reached values much higher than 1450 °C, which was the same feature observed for the sample previously placed at the interface with the insulating refractory (Fig. 5, Int).

Unlike the central and interface samples, the intermediate (M) and hot face (FR) ones showed signs of the vitreous phase and absence of anorthite, pointing out that this area faced temperatures as high as 1600 °C, which is the second indication that the main cause of the refractory damage could have been the high temperature.

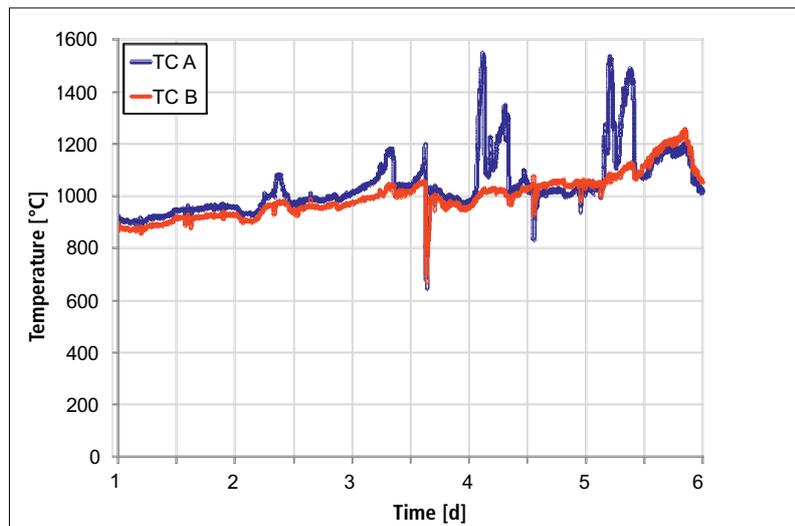
Fig. 6 Temperature as a function of time of two thermocouples (TCA or TCB) inserted in the highest temperature areas of the unit

Due to these results, the need of measuring the internal air temperature in the hottest vessels was required in order to confirm whether the refractory was really being excessively exposed to high temperatures. Thermocouples were placed in some critical inspection areas and temperature peaks (Fig. 6) as high as 1550 °C during specific periods were detected, which are in tune with the mineralogical investigation.

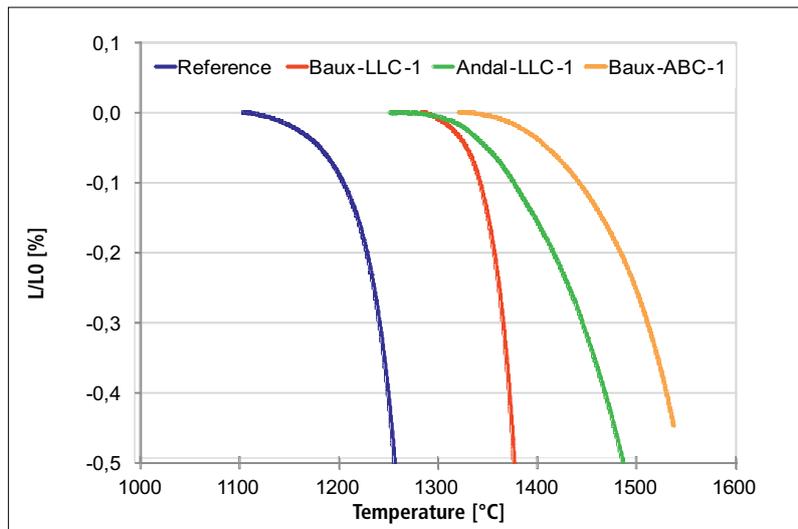
After this analysis, it became clear that the high temperatures could be at least an important factor responsible for the short life of the original refractory and that it should be added as a criterion for the selection of an alternative material. Therefore, three further products were selected in order to evaluate their maximum service temperature. All of them were prepared using traditional gunning as the installation method. Two of the evaluated gunning mixes were classified as low cement guns, which are commonly used in alumina calciners. One is a bauxite-based (Baux-LLC-1) and the other is an andalusite-based (Andal-LLC-1) refractory. The third option was a bauxite-based gunning mix bonded with an innovative alumina compound (Baux-ABC-1). This no-calcium oxide containing product has initially been considered with a higher refractoriness potential due to the lack of gehlenite and anorthite formation. The potential for higher refractoriness is reinforced by the use of a higher alumina content matrix. RUL tests (Fig. 7) confirmed the hypothesis of higher refractoriness for the Baux-ABC-1 product. Both the initial softening tempera-

ture and the maximum service one were higher than all low cement gun refractories, showing that it may present a better performance in the high temperature areas.

Fig. 7 Refractoriness-under-load (0,2 MPa) curves for all evaluated refractory products

After the technical characterization, it was clear that Andal-LLC-1 and Baux-ABC-1 products show a higher potential for replacing the reference material. Nevertheless, both refractories might work at their service limit in some working conditions. Because the Baux-ABC-1 product has further characteristics that provide a potential better performance of the equipment, it was selected for the future field trials.

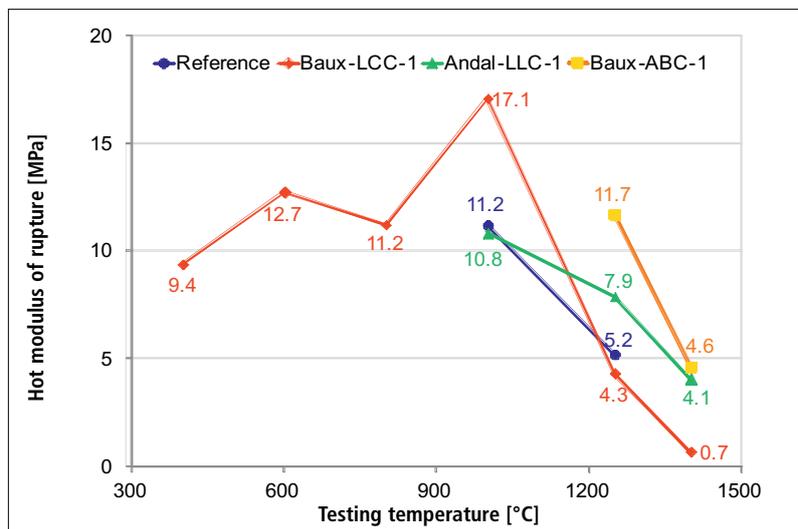
The most important feature of the hot mechanical strength results (Fig. 8) is that the Baux-ABC-1 material presented a similar strength level to the andalusite based product (Andal-LLC-1) at 1400 °C. If it is assumed that the refractoriness scales with mechanical strength at higher temperatures, this situation brings an apparent contradiction as the Baux-ABC-1 should present higher strength. Nevertheless, considering that the hot modulus of rupture (HMOR) test is under bending, it is possible to have a product with higher HMOR if it presents smaller surface defects and lower deformation resistance under compressive stresses, as in the refractoriness test, if the cohesion strength of the aggregates' bonding phase is low, which happens when a relatively large amount of liquid is present. This situation seems to be the case for the Andal-LLC-1 product.

Fig. 8 Hot modulus of rupture of the evaluated products

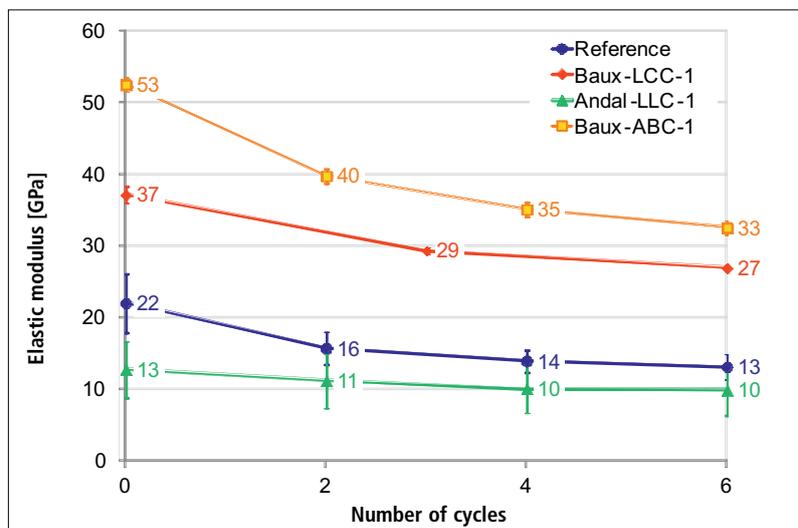
Moreover, the thermal shock results (Fig. 9) show that even having a higher relative elastic modulus decrease after 6 cycles (39 %), the Baux-ABC-1 resulted in a more rigid structure after the thermal cycles, which within the calciner may inhibit or at least delay the panels' cracking with time and temperature.

Fig. 9 Elastic modulus after thermal cycles for the evaluated products
