Refractory Corrosion in Industrial Waste Incineration Processes

The aim of this work was the evaluation of corrosion mechanisms of different refractories in operation of waste incineration plants. A testing method in steam atmosphere according ASTM was used to determine the oxidation resistance. Different silicon carbide materials with amounts of Si_3N_4 and $\text{Si}_2\text{N}_2\text{O}$ within their bonding phase composition were exposed to a constant steam flux at 900 °C with different time coordinates between 25 and 500 h. Since the same materials have been applied to industrial waste incineration plants an evaluation of the laboratory methods and the corrosion behaviour could be worked out and compared to the industrial performance of the bricks. Different established bonding phases have a strong influence on the oxidation behaviour resulting in micro- and macro-crack formation after application to corrosive steam environment. Different time dependant material behaviour for the volume change of the bricks was observed respectively.

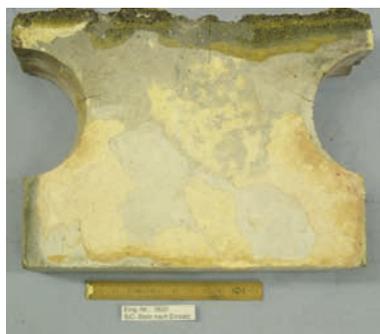
Fig. 1 Nitride bonded SiC after operation in an industrial waste incineration plant: Slag formation at the hot face, oxidation and crack formation

of performance of an incineration plant lining (Figs. 1 and 2). Thermal expansion behaviour is one example. In this study different lining areas and different refractory corrosion mechanism are described and discussed.

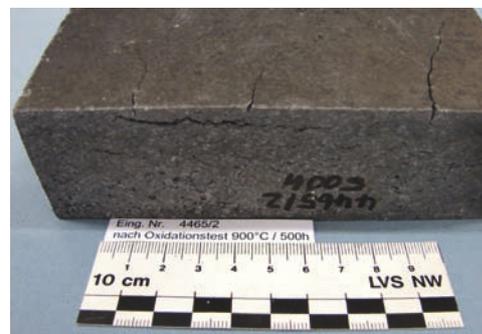
Fig. 2 Nitride bonded SiC after laboratory oxidation resistance test at 900 °C / 500 h: Crack formation and increase of volume
