Repair Action of Refractory Linings in High Temperature Reactors

H. Kern, U.-P. Steiner, R. Krebs

Over the last years repair operations in several plants and facilities (e.g. chemical plants, incineration and gasification plants) were realized, which still are permanently in operation. In this paper the authors describe some examples of efficient repairs on refractory linings of different high temperature reactors (HTR).

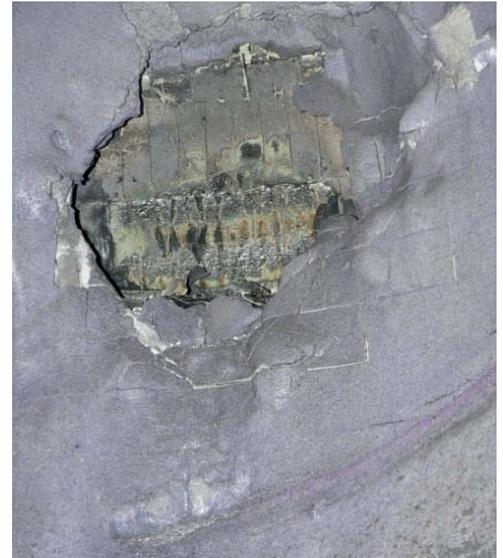
The first case was a hot spot in a reactor which was lined with bricks. There was a demand to repair partially destroyed bricks in the hot face layer like shown in Fig. 1. The damage was caused by a burner defect and the best method had to be found for repairing in this case. Thinkable were:

Fig. 1 Local damage of the hot face brickwork in a high temperature reactor (HTR)

- identification of the damaged area
- analysis of the failure reasons
- breaking out of the relevant area included insulation layer
- assembly of original and still available spare bricks as shown in Fig. 2.

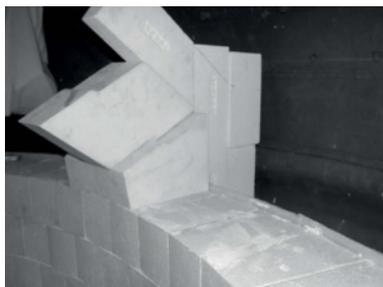
Fig. 2 Repair by bricklaying with high alumina dense bricks for the hot face and bubbled alumina LW-bricks for the backup insulation

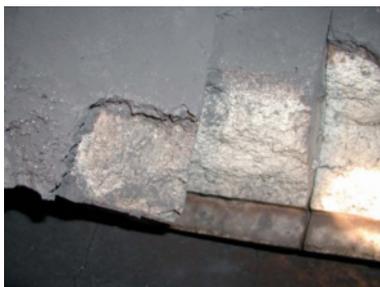
Fig. 3 Damages of supporting bricks inside a HTR, positioned on alloyed steel-consoles

Due to a little design imperfection the brickwork in the console-area (for carrying the upper brick-layers) has been damaged. The customer needed a very quick repair.

Sometimes replacement bricks are not available within a short time. In such cases the application of pre-formed shapes can help to realize proper repairs in very short times. The following example will explain the experience with tailor-made shapes made of a castable refractory (Fig. 3).

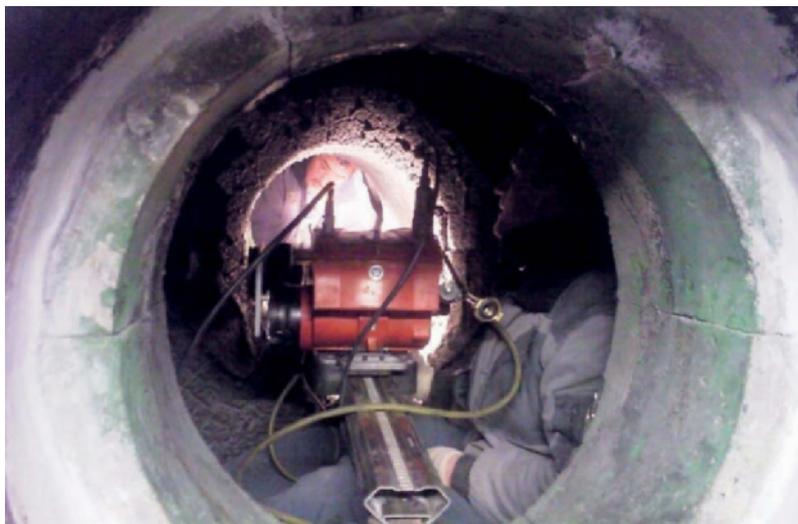
Fig. 4 Special cutting equipment for careful demolition (especially for dense bricks)

For removal of the damaged brickwork a special cutting technology (Fig. 4) was applied successfully, which is known and widely used in civil engineering and road construction. By use of this method a careful demolition could be made by minimizing destructive vibrations, which usually are developed by applying other break-out methods (pneumatic hammer, etc.). This advantage was necessary for avoiding any destructive shocks, which could loosen the residual brickwork structure.

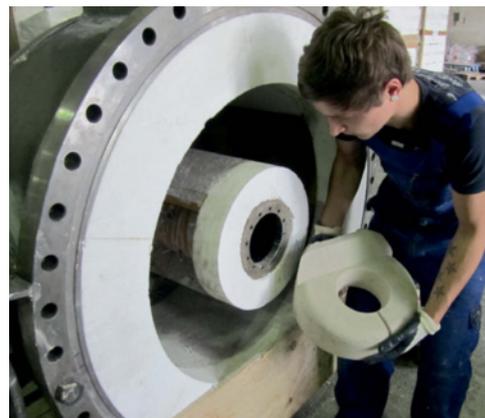
Fig. 7 Example for the installation of preformed shapes

Pre-formed shapes and preferably dehydrated or dried ones, made in a professional and well-equipped shop have distinctly better physical (and partially also chemical) properties than dry or wet applied refractory gunning mixes (Fig. 7). Their properties come mostly very near to the ones of the original lining materials, especially as far as physical properties are concerned.

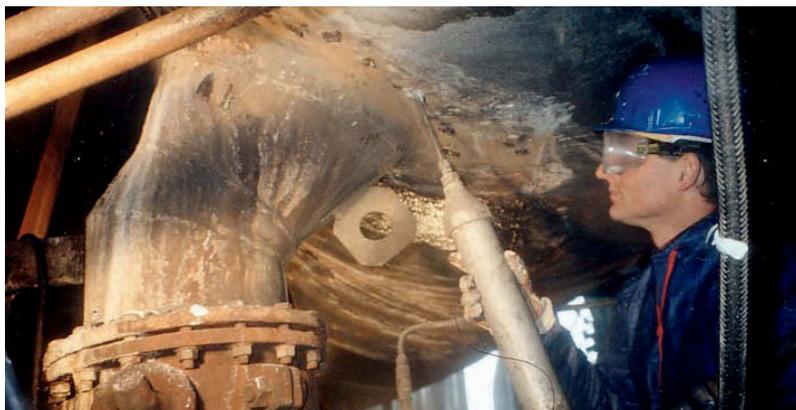
Fig. 10 Hot spot repair of a BF of a hot blast duct by injection of fibre-mastic with a Quickplaster

In the back-up insulation a formation of holes were detected and a dangerous temperature increase occurred at the metal shell. To prevent a shutdown of the duct, the holes and gaps in the lining were filled with fibre mastic for 1500 °C service temperature. After drilling several holes into the steel shell the product was injected by the so called Quickplaster like shown in Fig. 10. The holes in the shell have been closed by welding and an untroubled operation of the furnace could be avoided.

The repairing of a hot spot on a hot blast duct of a blast furnace at *Arcelor-Mittal* shall be described as an example.
