# Microstructural Analysis of Magnesia Bricks Operating under Altered Conditions in the Regenerator Condensation Zone of Glass Melting Furnaces

Chr. Majcenovic, G. Gelbmann, R. Bei

Keywords: magnesia bricks, glass melting furnace, microstructural changes

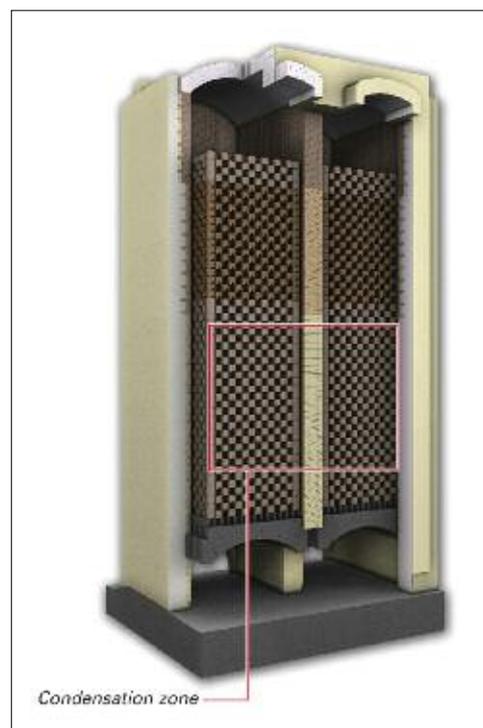
**Fig. 1** Glass tank regenerator: the condensation zone has a temperature range of approximately 700–1100 °C (source: RHI AG)
