Interactions between Molten Aluminum and Various Refractory Materials

V. Schönhof, W. Schönwelski, J. Sperber, M. Bay

Journal of Ceramic Science and Technology 5 (2014) [2]

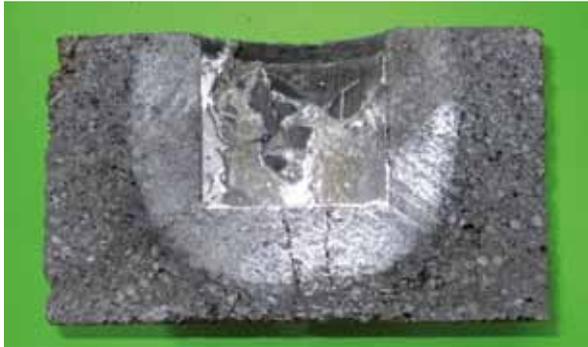
Fig. 2 Al-crucible test of SC 90, dwelling time: 72 h, temperature: 850 °C

SC 90: Crucible test with SC 90 (silicate bonded SiC) (Fig. 2) shows a circular infiltration of 14 mm depth. The metallic reflection of this area suggests a mechanical infiltration. Compared to the rest this zone is denser. Especially when temperature changes take place the densification may result in spalling [9]. Knowing that the SiC component is proved to be stable, an alternative binding system for silicate binding is preferred.

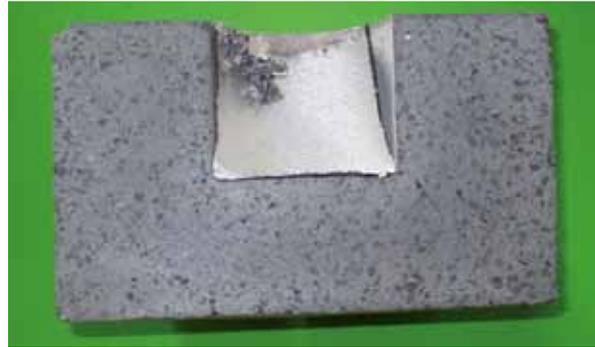
Fig. 3 Al-crucible test of SCN 70, dwelling time: 72 h, temperature: 850 °C

SCN 70: According to literature a Si_3N_4 - or Si_2ON_2 bound SiC-bricks have good resistance against molten aluminum [10]. We tested our nitride bonded quality SCN 70. In contrast to the SC 90 the SCN 70 (nitride bonded SiC) (Fig. 3) has a very high corro-

sion resistance. No structure changes and no infiltration can be observed. After pouring off the melt, the aluminum skin can be detached from the crucible surface and there has been no wetting. Spare literature information about the contact angle θ of

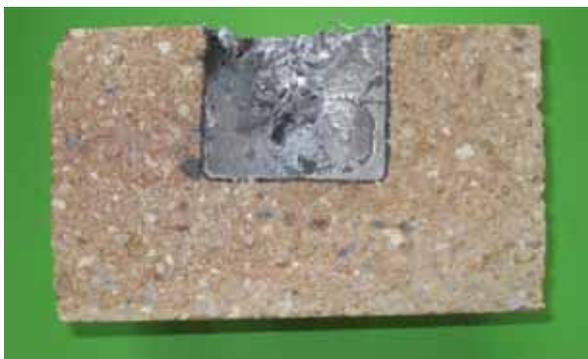
Fig. 6 Al-crucible test of B 80, dwelling time: 72 h, temperature: 850 °C

B 80: The test of B 80 (fired bauxite brick containing phosphate) (Fig. 6) shows that there are no differences of corrosion behaviour between the 850 °C and 1100 °C test. This shows that bauxite bricks can be exposed higher temperature fluctuations in the aluminum industry.

An infiltration depth of 1 mm can be seen. In this zone a chemical reaction between the components and aluminum takes place. Al_2O_3 was built by reaction of aluminum with the SiO_2 -containing matrix of the bauxite brick [14]:

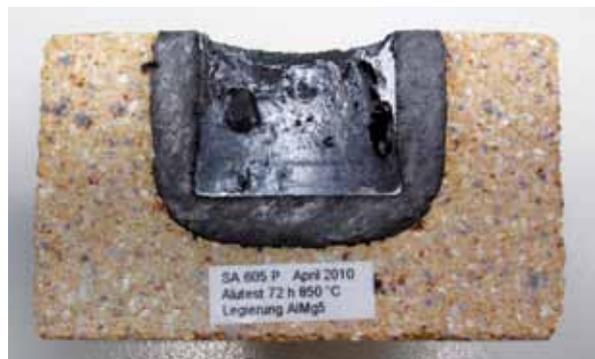
Fig. 7 Al-crucible test of SA, dwelling time: 72 h, temperature: 850 °C

SA: At the crucible test with SA (fired andalusite brick) (Fig. 7) a corrosion attacked and densified zone with a depth of 11 mm can be seen. Along the border of reaction layer and the structure a crack has appeared. This will unavoidably lead to spalling, which results in a rapid loss of material.
