# Investigation of Corrosion Mechanisms between Copper and Lead Melts with Various Refractory Materials

In this article the different interactions between molten copper and lead and various refractory materials are investigated by crucible tests. The refractory bricks were chrome-corundum resp. chrome-zirconia-corundum bricks and silicate-bonded and nitride-bonded silicon carbide bricks. The test samples were analysed by:

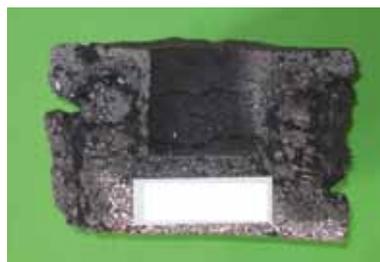
Fig. 1 Cu-crucible test of CK 9 in oxidizing atmosphere

The crucibles have massively been attacked. Under oxidizing conditions the crucible was nearly totally destroyed (Fig. 1). Under reducing conditions the appearance was not much better (Fig. 2). Microscopic observation showed that the matrix but also the coarse grains are attacked, but in a different degree (Fig. 3 – 4). Obviously chemical

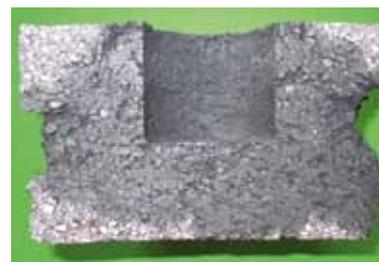
Fig. 2 Cu-crucible test of CK 9 in reducing atmosphere

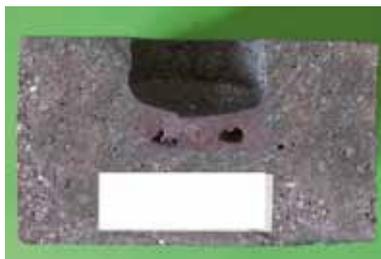
**Fig. 5** Cu-crucible test of CZK 5 in oxidizing atmosphere

Under ox. conditions the copper has visually totally reacted, with oxygen coming from the air as well as with refractory components (Fig. 5). Reaction products are partly crystalline with a columnar shape, others are more isometric, but most of it seems to be amorphous or has a homogenous matrix-like structure (microscopic picture Fig. 6).

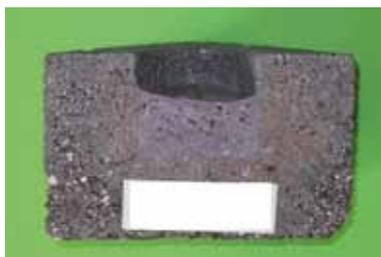
**Fig. 9** Cu-crucible test of CZK 15 in oxidizing atmosphere

Under ox. conditions more copper slag remains in the crucible and the infiltration zone is smaller compared to CZK 5 (Fig. 9). The same is the case for red. conditions (Fig. 10).

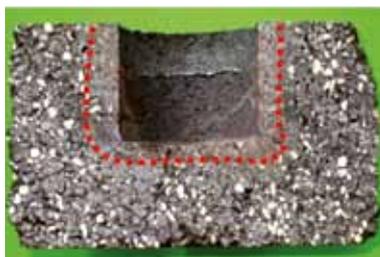
**Fig. 10** Cu-crucible test of CZK 15 in reducing atmosphere

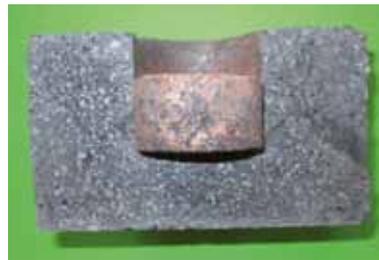
**Fig. 13** Cu-crucible test of SC 90 in reducing atmosphere

There is absolutely no reaction visible for reducing conditions (Fig. 13), oxidising there is some small surface reaction (Fig. 14). This is confirmed by microscopic pictures (Fig. 15–16), where only small droplets of metallic copper inclusions can be detected ox. SEM and XRD of the ox. tests show a small zone of  $\text{SiO}_2$  on the refractories surface (Fig. 17), protecting the SiC grains from mechanical disintegration. Microanalysis shows that the copper droplets inside contain some silicon.

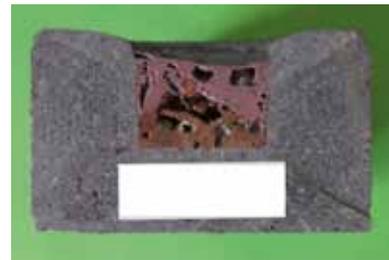
**Fig. 14** Cu-crucible test of SC 90 in oxidizing atmosphere

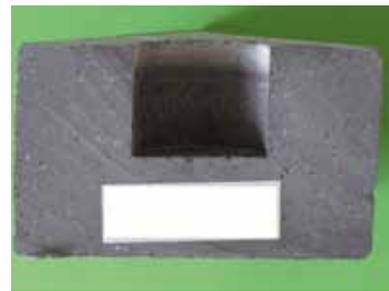
**Fig. 18** Cu-crucible test of SCN 70 in reducing atmosphere

The behaviour of nitride bonded SiC is slightly better but similar to ceramic bonded SiC: absolutely no wetting under reducing conditions (Fig. 18), just sticking and a small oxidised surface when oxygen has access (Fig. 19). The microscopic picture shows that the protecting layer is about three times thicker than for SiCs 90. Nitrid-

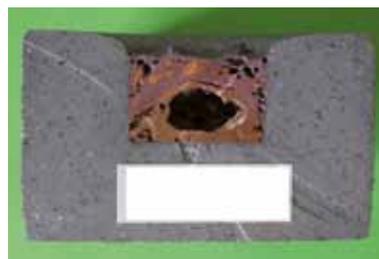
**Fig. 19** Cu-crucible test of SCN 70 in oxidizing atmosphere

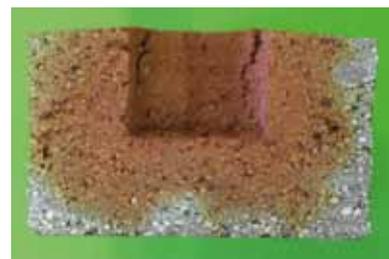
**Fig. 20** Pb-crucible test of CK 9 in oxidizing atmosphere

Similar to copper, lead destroys the structure of the crucibles heavily under ox. conditions, under red. conditions the effect is smaller but still destructive (Fig. 20–21).

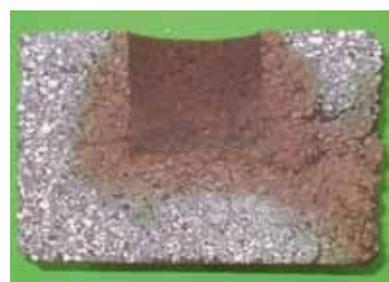
**Fig. 21** Pb-crucible test of CK 9 in reducing atmosphere

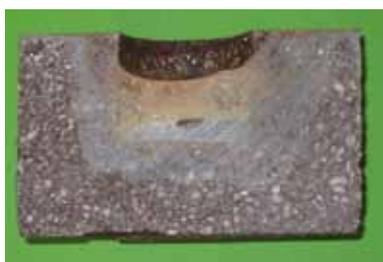
**Fig. 22** Pb-crucible test of CZK 5 in oxidizing atmosphere

Oxidizing: the crucible is infiltrated and a big layer of lead oxide has formed on the surface of a residual metal rest (Fig. 22). Reducing: the crucible is infiltrated and the rest of metal could be poured out after the test (Fig. 23). Under the microscope one can see needle-shaped crystals, a glassy matrix and largely uncorroded chrome-corundum coarse grains in the reaction zone (Fig. 24–26). SEM and XRD identify lead silicate  $Pb_{11}Si_3O_{17}$ , lead chromate  $Pb_2CrO_5$  and  $PbO$  and a lot of amorphous phase to

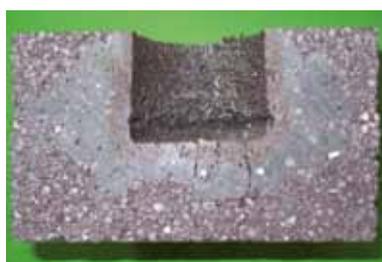
**Fig. 23** Pb-crucible test of CZK 5 in reducing atmosphere

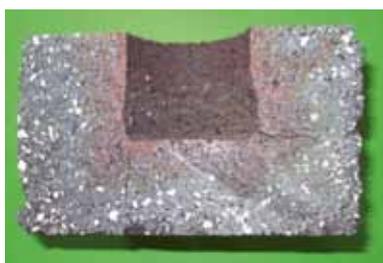
**Fig. 28** Pb-crucible test of CZK 15 in reducing atmosphere

So it was not a surprise that the higher chromium content and the presence of zirconia in this sample was not an improvement. Oxidizing: the crucible was corroded and the lead complete vanished, infiltrating the refractory (Fig. 27). Reducing: the crucible was infiltrated to about 20 mm, some corrosion and cracks appeared in this zone (Fig. 28). The microscope shows that the high-chromium matrix and the zirconia containing grains are totally destroyed (Fig. 29–30), but the alumina grain have only a seam of reaction (Fig. 31–32). This is more or less both for reducing and oxidizing conditions the case. XRD identify lead zir-

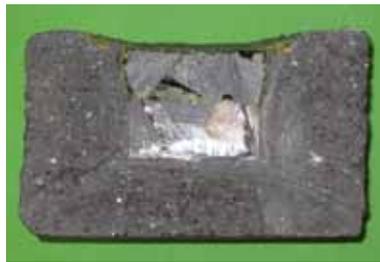
**Fig. 34** Pb-crucible test of SC 90 in oxidizing atmosphere

Under oxidizing conditions a lot of lead silicate glass is formed, overboils out of the bore and covers the whole crucible surface (Fig. 33). As the glassy phase “seals” and protects against oxygen access, residuals of metal remain on the crucible bottom and corrosion mainly takes place in the upper parts (Fig. 34). The microscope exhibits the dissolution of the silicate matrix by lead oxide and the SiC grains remain unattacked, but are washed away by the melt (Fig. 35). XRD shows no crystalline reaction products, what confirms that it is amorphous. There is absolutely no infiltration or corrosion visible under reducing conditions.

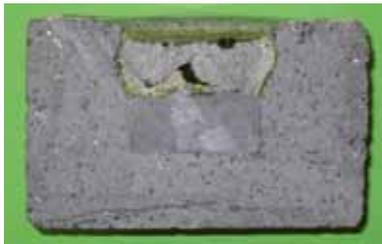
**Fig. 36** Pb-crucible test of SCN 70 in oxidizing atmosphere

The nitride-bonded SiC-brick again shows no wetting, so no corrosion or infiltration. Examinations did not make sense resp. did not indicate any structure changes. In the zone of the melt formation under ox. conditions (Fig. 36) there is erosion visible, but under the microscope the mechanism of “washing out” the SiC-grains cannot be observed. This indicates that a similar corrosion mechanism like for silicate bonded material must take place, but to a much lower degree. The nitride bond is much more re-

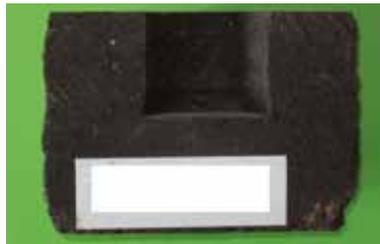
**Fig. 37** Cu-crucible test of MCr

Just for comparison reasons older crucible test have been paid attention too, namely magnesia chromite bricks and pure corundum. The magnesia chromite brick was totally infiltrated by both metals and the crucible content completely vanished (Fig. 37 and 38). The same happens with lead and pure corundum (Fig. 39). In all cases no corrosion or erosion is visible. The authors could not test if there is any influence of this infiltration on the thermomechanical properties of the bricks, but they estimate there is. All we could see is that some new phases are formed with the magnesia chromite brick; gueggenite  $MgCuO_x$  in the case of copper and some undefined lead compounds in the case of lead. Only the pure

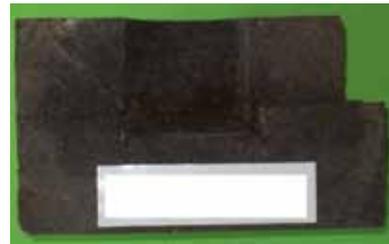
**Fig. 38** Pb-crucible test of MCr

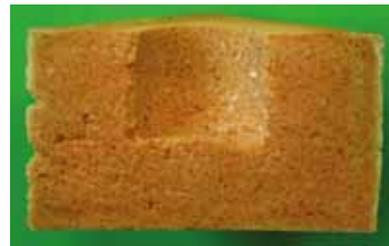
**Fig. 39** Pb-crucible test of KE 99

corundum treated with lead does not show new reaction phases, only glassy lead oxide PbO.
